Black Hawk Helicopter Vibration Analysis Due to Main Rotor Damage, Directional Constituents of the Resultant Vibrations

ARL-TR-2442

March 2001

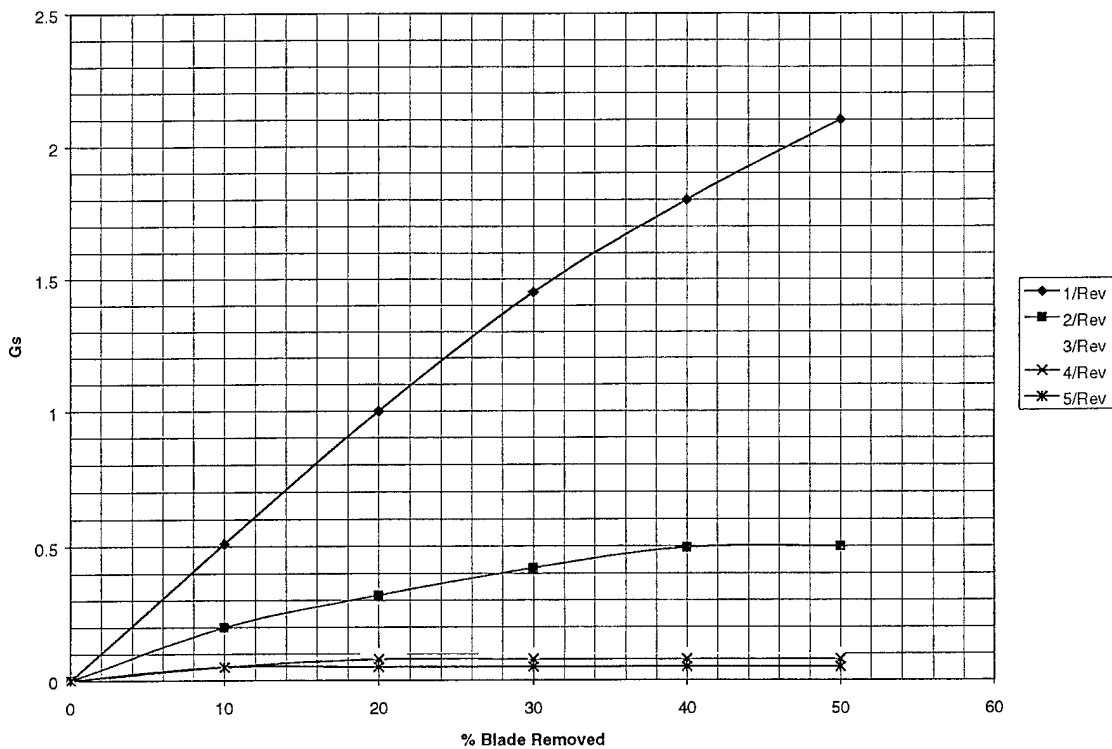
Figure 1. Cockpit resultant vibrations G's vs. percent of blade removed.

There is a predominate 1/Rev frequency getting through to the cockpit that ordinarily would be filtered out for undamaged blades of the set of four, and there is also a significant 2/Rev. The higher frequencies have low amplitudes, and it should be noted that the 4/Rev would be the only frequency transmitted if no damage were present.

First, the resultant vibrations are shown in Figure 1 as G's (gravitational pull) vs. percent of the removal of the outer blade section.

From Figure 1, it was found that the 1/Rev is the biggest resultant vibration, and the makeup in Figure 2 shows that the vertical cosine component is the biggest constituent followed by the lateral sine. The longitudinal cosine and vertical sine follow next in absolute amplitude. In a normal undamaged rotor, none of these 1/Rev vibrations would occur for a 4-bladed rotor.

From Figure 1, it is seen that the dominant cockpit vibration comes from 1/Rev, which is the frequency of the main rotor (1×258 rpm) followed by the 2/Rev (2×258 rpm) in amplitude. As the frequency increases, the amplitude of vibration decreases as would be expected except if there is no resonance in the system. A separate study would be needed to determine how these vibrations might fatigue the structure of the aircraft or affect a pilot's ability to fly the aircraft.

Figure 1 shows the cockpit vibration to be above 2 G's for the high-speed condition with half of one blade's outer portion lost. Further performance analysis would be needed to determine the helicopter's residual capability to survive or the pilot's capability to perform. Helicopter first principles can be found in works by Chopra [2], McCormick [3], and Saunders [4].

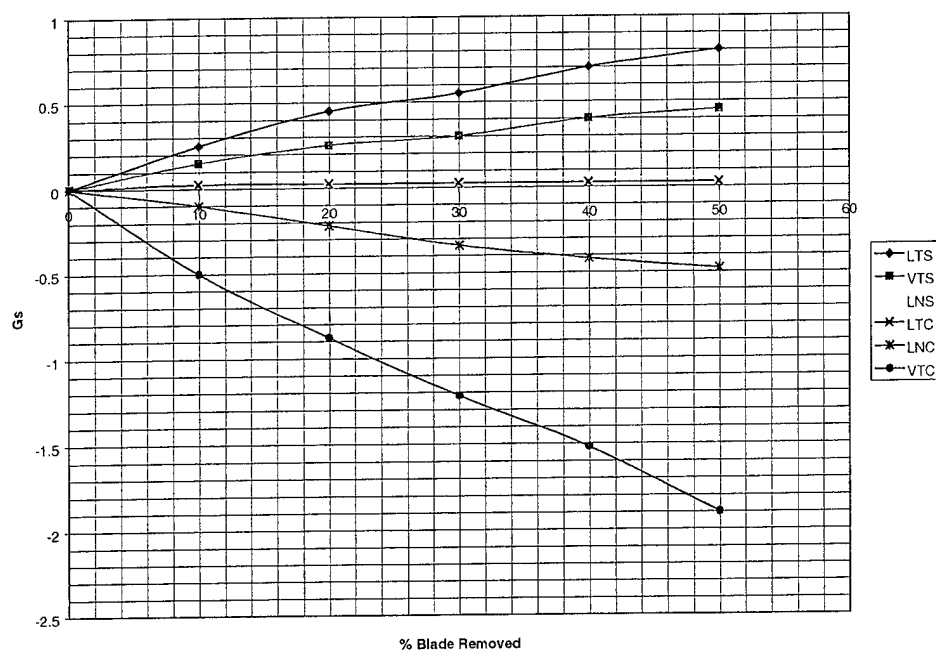
Figure 2. 1/Rev cockpit constituent vibrations G's vs. percent of blade removed.

Next, the individual harmonics are viewed one at a time, and the directional cosine and sine components are distinguished. In Figure 2, the legend is defined as follows:

- LNC = Longitudinal Cosine Vibration
- LNS = Longitudinal Sine Vibration
- LTC = Lateral Cosine Vibration
- LTS = Lateral Sine Vibration
- VTC = Vertical Cosine Vibration
- VTS = Vertical Sine Vibration

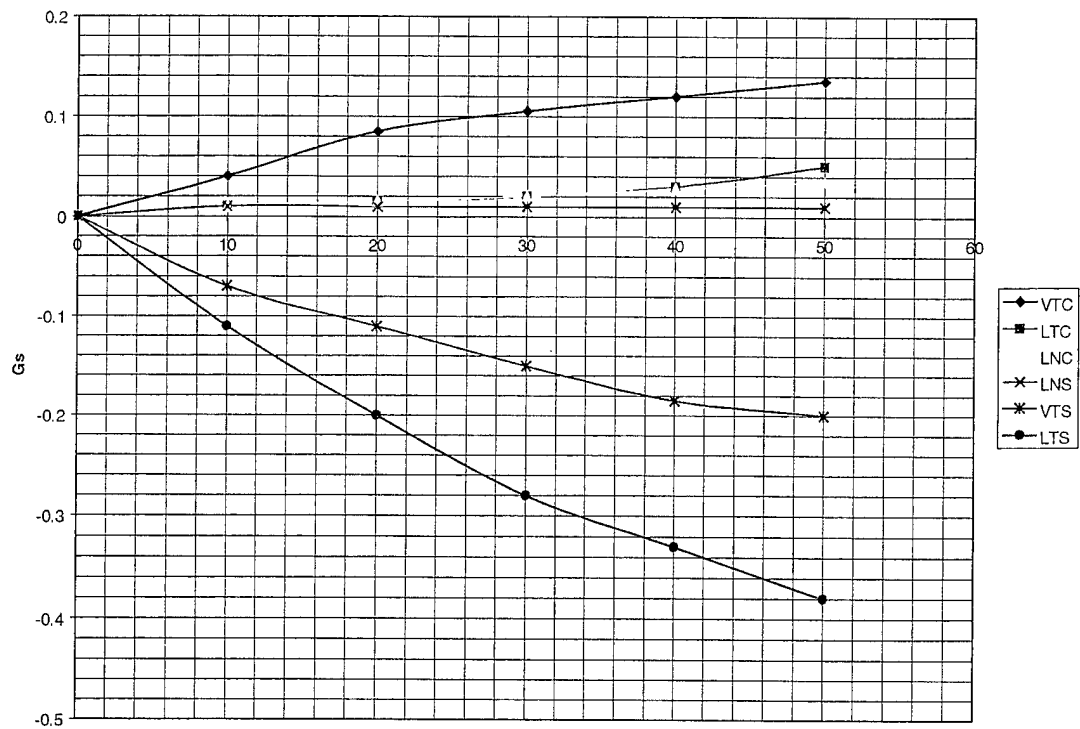
Next in order are the 2/Rev vibrations illustrated in Figure 3. In a normal undamaged rotor, none of these 2/Rev vibrations would occur for a 4-bladed rotor.

Figure 3. 2/Rev cockpit constituent vibrations G's vs. percent of blade removed.

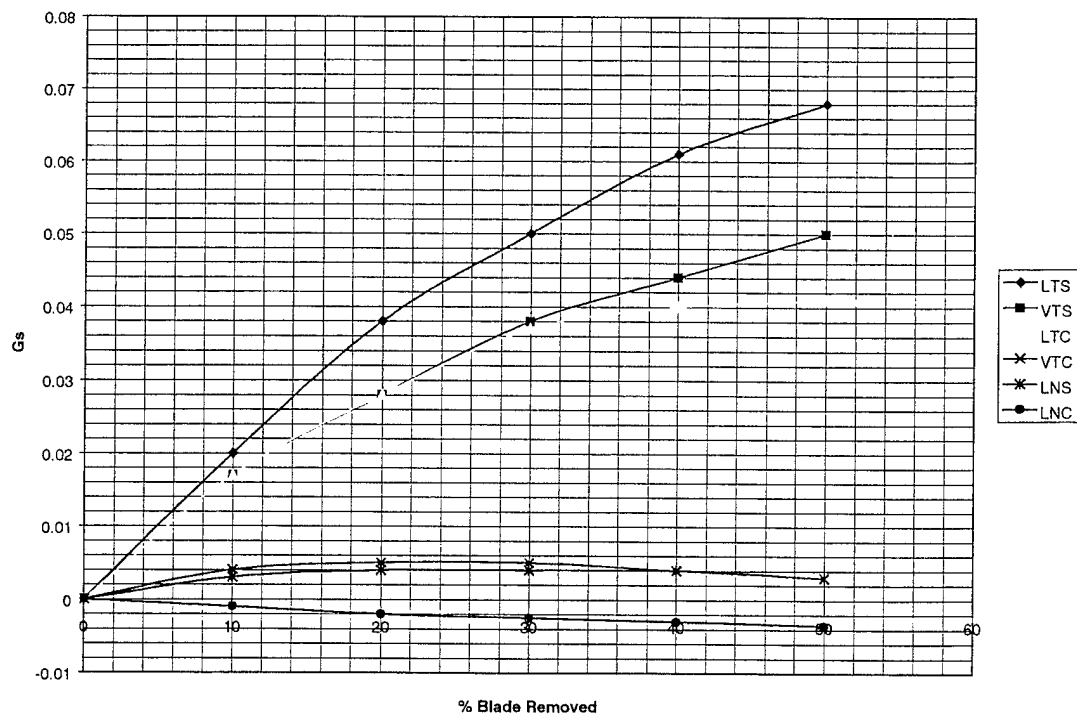
Next are the 3/Rev vibrations illustrated in Figure 4. In a normal undamaged rotor, none of these 3/Rev vibrations would occur for a 4-bladed rotor.

Figure 4. 3/Rev cockpit constituent vibrations G's vs. percent of blade removed.

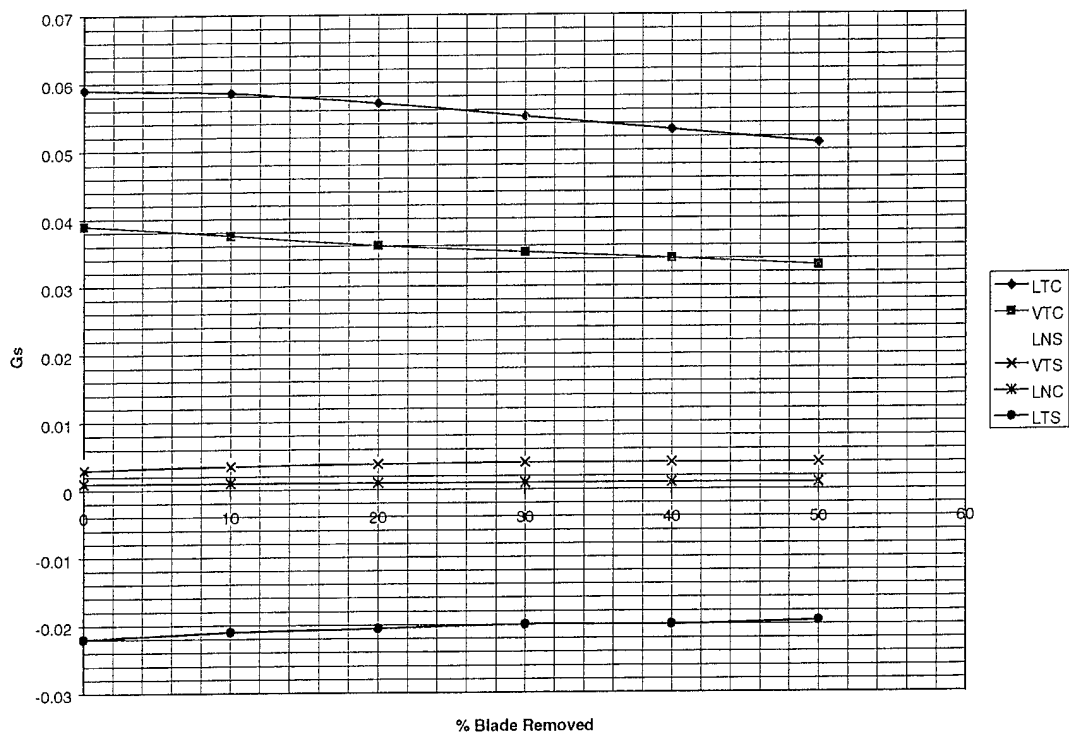
The 4/Rev vibrations are illustrated in Figure 5. Notice that the vibrations for the undamaged blade (at 0% blade removed) are not zero. This is significant and points to the fact that 4/Rev is an integer number of the blades in the rotor and is not filtered out; it is an inherent vibration that always exists. Also notice that the amplitudes of these inherent vibrations are relatively low compared to the 1/Rev that exists when a blade is damaged. These are inherent 4/Rev vibrations that are always present in the cockpit for a 4-bladed rotor.

Figure 5. 4/Rev cockpit constituent vibrations G's vs. percent of blade removed.

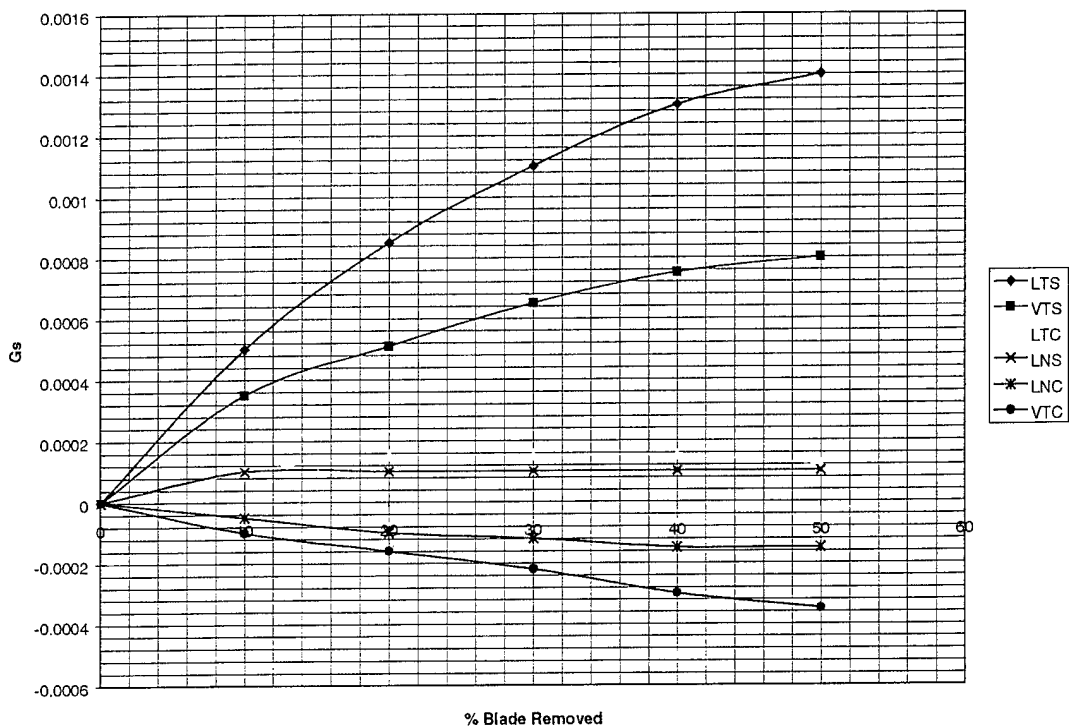
Finally, the 5/Rev vibrations are illustrated in Figure 6. The amplitudes are very small, which is as expected for the higher frequencies. Therefore, there is no need to continue to list the higher frequencies. None of these vibrations would occur for an undamaged 4-bladed rotor.

Figure 6. 5/Rev cockpit constituent vibrations G's vs. percent of blade removed.
